# ANNUAL REPORT FOR 2007

**Marks Creek Mitigation Site**  
**Wake County**  
**TIP No. R-2547WM**

Prepared By:  
Natural Environment Unit & Roadside Environmental Unit  
North Carolina Department of Transportation  
January 2007

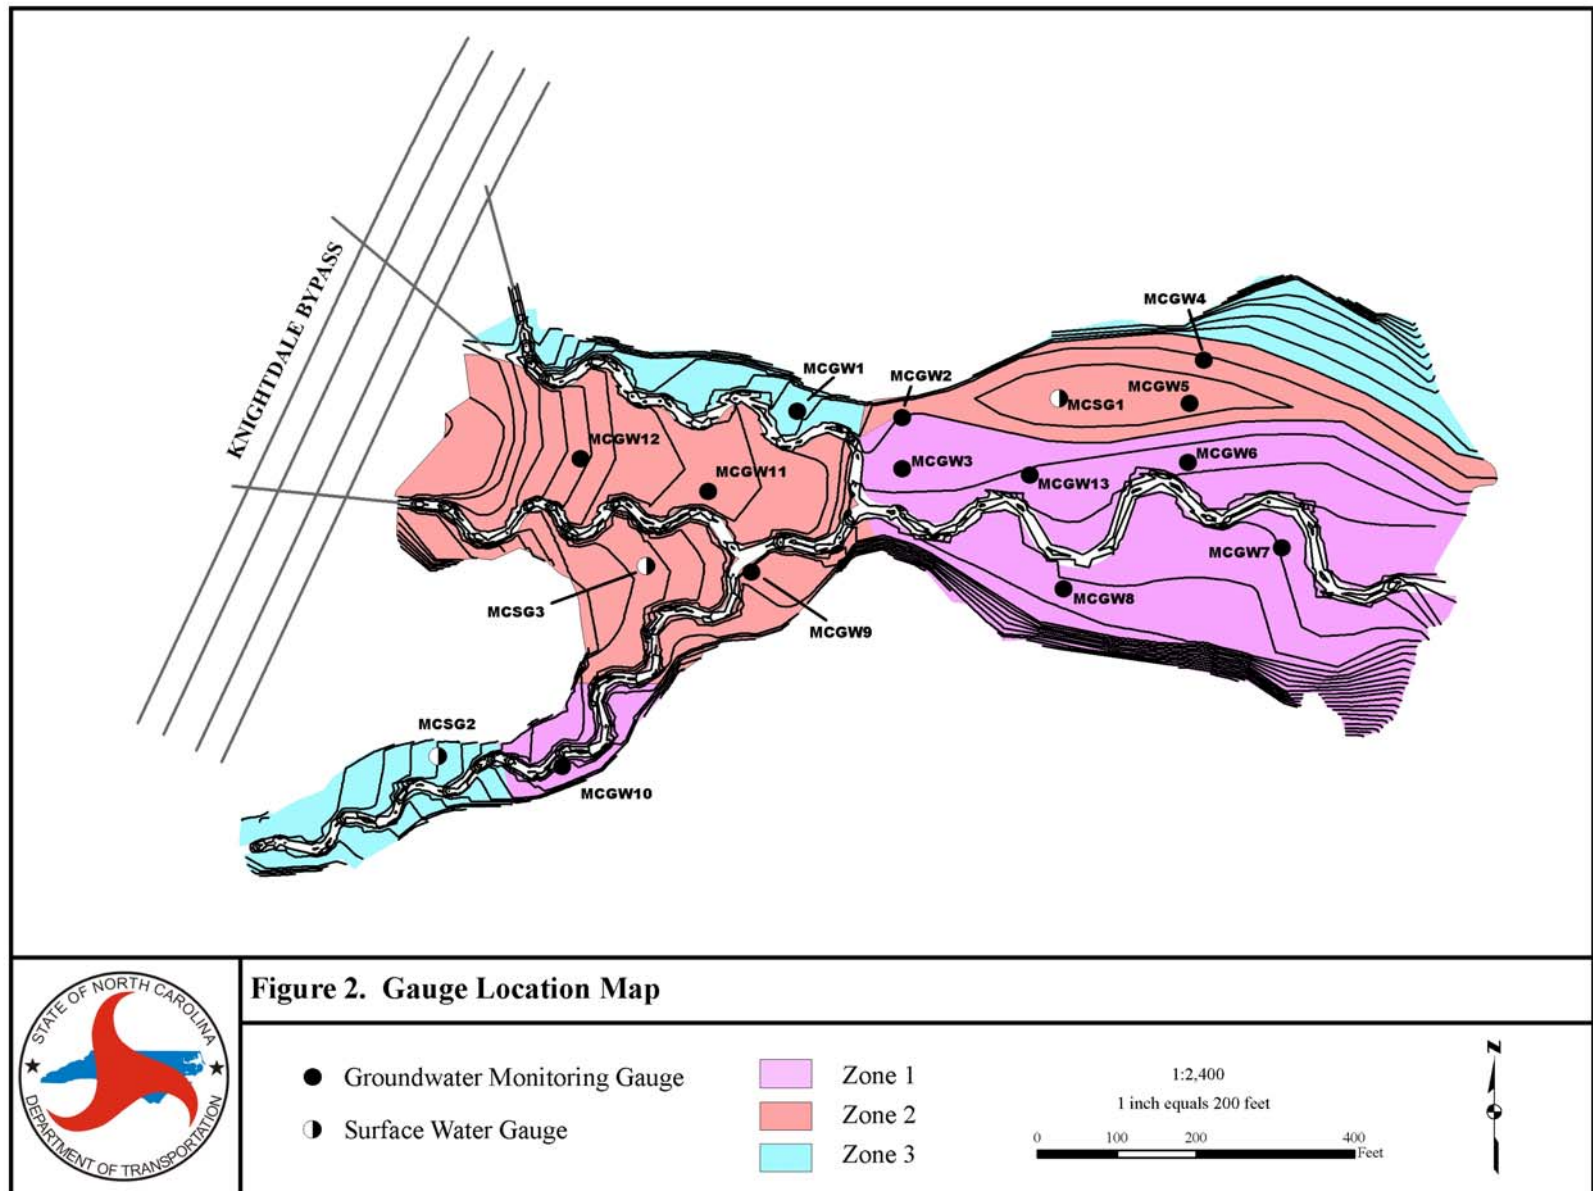
**Figure 2. Gauge Location Map**

In June of 2003, twelve groundwater-monitoring gauges and three surface water-monitoring gauges were installed across the site (Figure 2). In July of 2005, one additional groundwater gauge was installed. The groundwater gauges are set to record daily water levels, while the surface water gauges are set to record at 4-hour intervals. A rain gauge is also located on the site in order to get accurate site rainfall measurements. The hydrologic response (groundwater) to rainfall events is evaluated using this data.

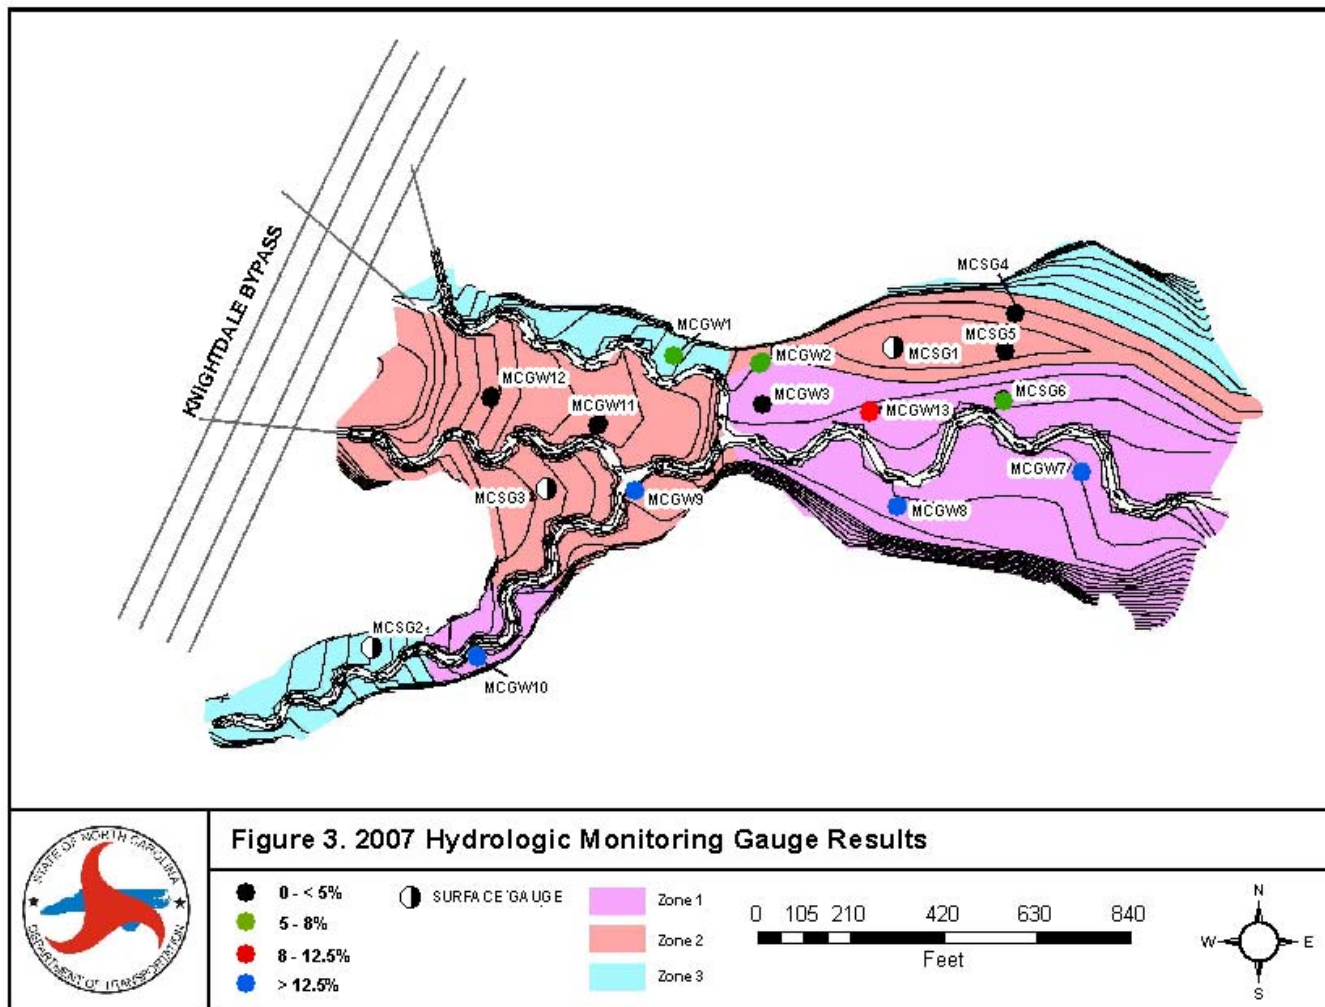
**Figure 3. 2007 Hydrologic Monitoring Results**

Figure 3 provides a graphical representation of the hydrologic results. Gauges highlighted in blue indicate wetland hydrology for more than 12.5% of the growing season. Gauges highlighted in red show hydrology between 8% and 12.5% of the season, while those in green indicate hydrology between 5% and 8% of the season. Gauges highlighted in black indicate no wetland hydrology (less than 5% of the growing season). Please note that gauges shown in red or blue meet the hydrology criteria in Zones 2 & 3.

The 2007-year represents the fourth year of hydrology monitoring on the Marks Creek Site. Three of the seven monitoring gauges located in zone 1 met the hydrology success criteria of 12.5% for the 2007-growing season. One of the six monitoring gauges located in zone 2 and 3 met the hydrology success criteria of 8.0%. Gauges MCGW-1, MCGW-2, MCGW-3, MCGW-4, MCGW-5, MCGW-6, MCGW-11, MCGW-12, and MCGW-13 did not indicate successful hydrology. All three surface water gauges demonstrated periods of inundation throughout the growing season.

For the fourth year of monitoring, three of the seven monitoring gauges located in zone 1 met the hydrology success criteria of 12.5% for the 2007-growing season. One of the six monitoring gauges located in zones 2 and 3 met the hydrology success criteria of 8.0%. Gauges MCGW-1, MCGW-2, MCGW-3, MCGW-4, MCGW-5, MCGW-6, MCGW-11, MCGW-12, and MCGW-13 did not indicate successful hydrology. All three surface water gauges demonstrated periods of inundation throughout the growing season. The failure of the nine-groundwater gauges to meet the success criteria is attribute to the extreme drought conditions experienced in the area during the 2007 growing season

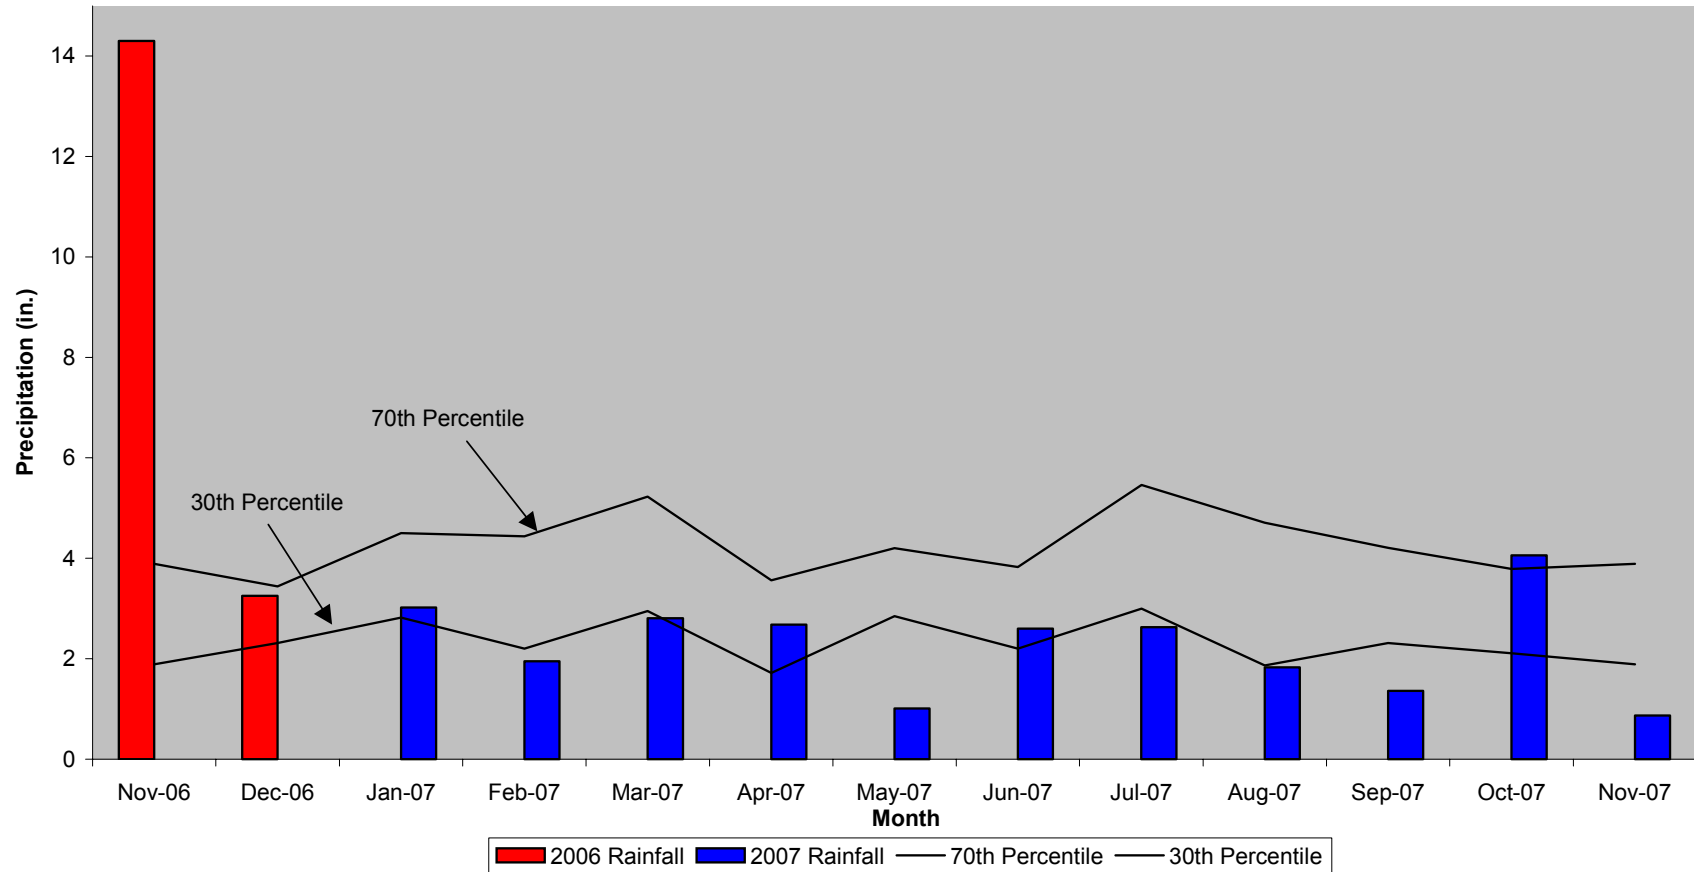
**Figure 4. 30-70 Percentile Graph**

Figure 4 provides an examination of the local climate in comparison with historical data in order to determine whether 2007 was “average” in terms of climate conditions. The two lines represent the 30<sup>th</sup> and 70<sup>th</sup> percentiles of monthly precipitation for Raleigh. The bars are the monthly rainfall totals for November 2005 through November 2007. The NC State Climate Office collected the historical data for the Raleigh/Durham weather station.

For the 2007-year the below average rainfall months include: May, June, July, August, September, October, and November. The months of January, February, and March recorded average rainfall. Overall, the site experienced below average rainfall in 2007 due to the drought.
